Image analysis methods for automating furrow irrigation

Introduction

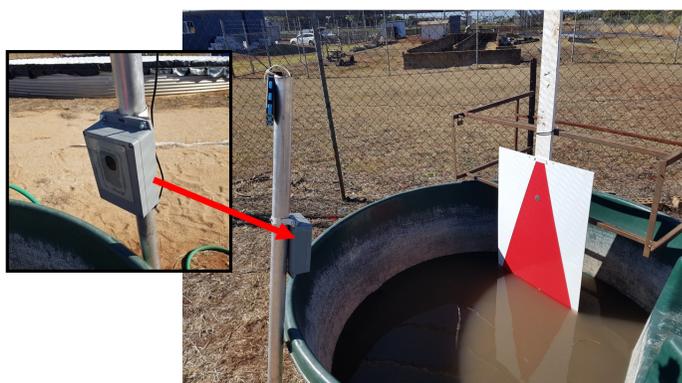
The image analysis software maps the water level against a calibrated reference sign (shown above). An accuracy of ± 5 mm was achieved in preliminary testing, suggesting the system could match the accuracy of existing pressure sensors.

USQ has been developing a low-cost smartphone camera system to replace the expensive sensors used in irrigation channels. An app was developed for the smartphone to:

- periodically take a photo of the water level in the channel;
- process each image to determine water level; and
- transmit water level through a cellular connection to for display on the grower's phone or tablet.

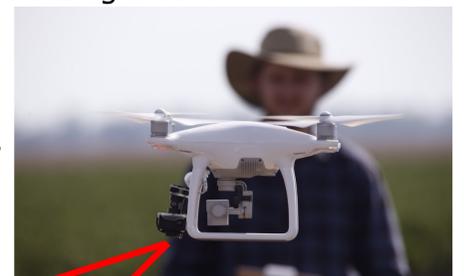
The thermal sensor does not require light to reach the base of the crop, and thus can detect water in later crop growth stages when canopy closure obscures the view of the ground to standard colour cameras (as shown below).
